# **Pentium<sup>®</sup> II Processor Specification Update**

Release Date: June 1998

Order Number: 243337-015

The Pentium<sup>®</sup> II processor may contain design defects or errors known as errata which may cause the product to deviate from published specifications. Current characterized errata are documented in this Specification Update.

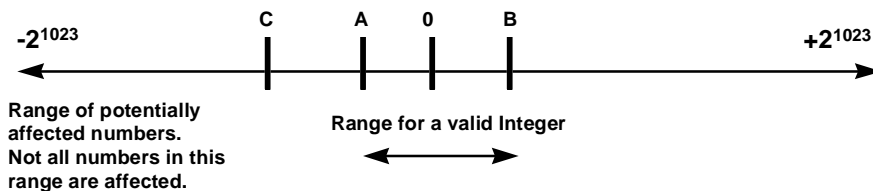
**IMPLICATION:** Erroneous operation results when the operand is so large that it will not fit into the target data size. The operands affected by this erratum are significantly outside (by a factor of 3X) the range that can be, correctly, converted to an integer value. The figure below and corresponding table identifies the normal range of integer numbers (between A and B) and the starting point of the operands affected by this erratum. Discrete failing operands will be present in the range between point C and the maximum negative number that can be represented by the processor ( $-2^{1023}$  in double precision format). Note 2 below gives a qualitative description of the nature of the discrete failing values. Software that does not rely on the Invalid Operation exception flag being set and signaled by either an exception OR by software polling is not impacted by this erratum.

16-bit Operation	A	B	C
	-32,768.0	+32,767.0	< -98304.0
32-bit Operation	A	B	C
	-2,147,483,648.0	+2,147,483,647.0	< -6,442,450,944.0

**WORKAROUND:** Any of two software workarounds will avoid occurrence of this erratum:

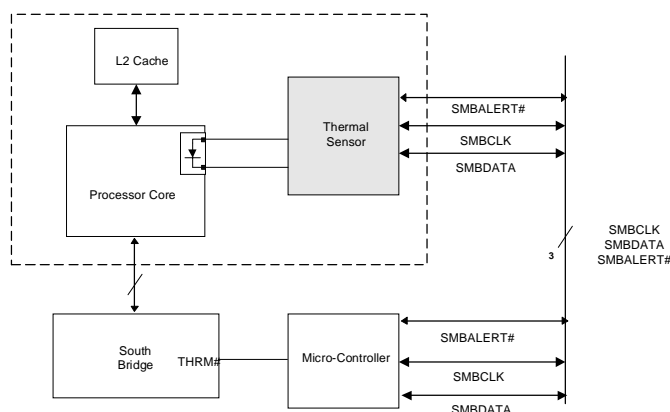
**Figure 4. An Example of Micro-controller Driven Thermal Management**

**PROBLEM:** The Mobile Pentium II processor and the Pentium II processor Mobile Module have a thermal sensor that monitors the processor core's temperature. Please note that desktop systems could have a similar thermal device. The thermal sensor asserts SMBALERT# if the processor temperature exceeds the temperature limits set in the Alarm Threshold Registers ( $T_{HIGH}$ ,  $T_{LOW}$ ). It also sets the corresponding Status Register bits to identify the cause of the interrupt. Figure 4 gives one example of the how the SMBALERT# signal could be used in a system.

Under the conditions described below, the thermal sensor incorrectly generates the SMBALERT# interrupt. **All** of the following conditions must be met to trigger a false interrupt:
